TREE PROTECTION PLAN

PRECISION COUNTERTOPS

25540 SW GARDEN ACRES ROAD,
SHERWOOD, OR 97140

Date Tuesday, April 4, 2023

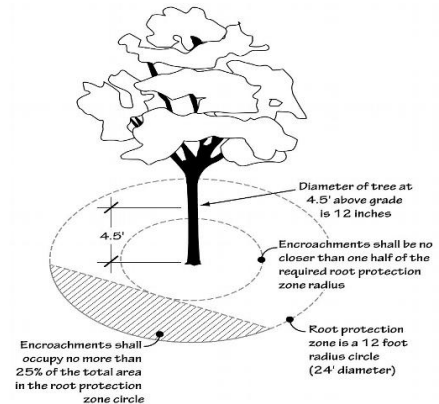
The plans indicate that the 30-foot setback on the south side of the property is to be used as a paved access road and parking lot. The neighbor's trees are directly adjacent to the property line and the proposed flatwork will impact trees #t1 through #t33. It is typically accepted that the tree protection zone of a tree is 12X the diameter of the tree with an allowable encroachment up to half the tree protection zone on one side of the tree. This ensures that no more than 25% of the total root structure of the tree is potentially impacted. The proposed site improvements, according to the plans, show that up to 50% of the root structures will be impacted.

It may be recommendable to eliminate the proposed pavement south of the building unless alternative construction methods and materials are used to accomplish the construction goals. If pavement is to be installed, it is recommended that the existing grade remains and that the existing soil is not excessively disturbed. The subgrade and flatwork should be built up from native grade and pervious materials should be used to avoid hydrology changes. Utilizing storm water to trees approaches for the parking lot may be a viable way to limit the soil hydrology changes by allowing the water runoff to filter through planter areas into the native soil prior to discharging into the municipal system. The trees and other vegetation will absorb a significant amount of rainwater limiting the amount that is discharged into the system. Minimizing hydrology changes will ensure that the retention of the neighboring trees will be more successful.

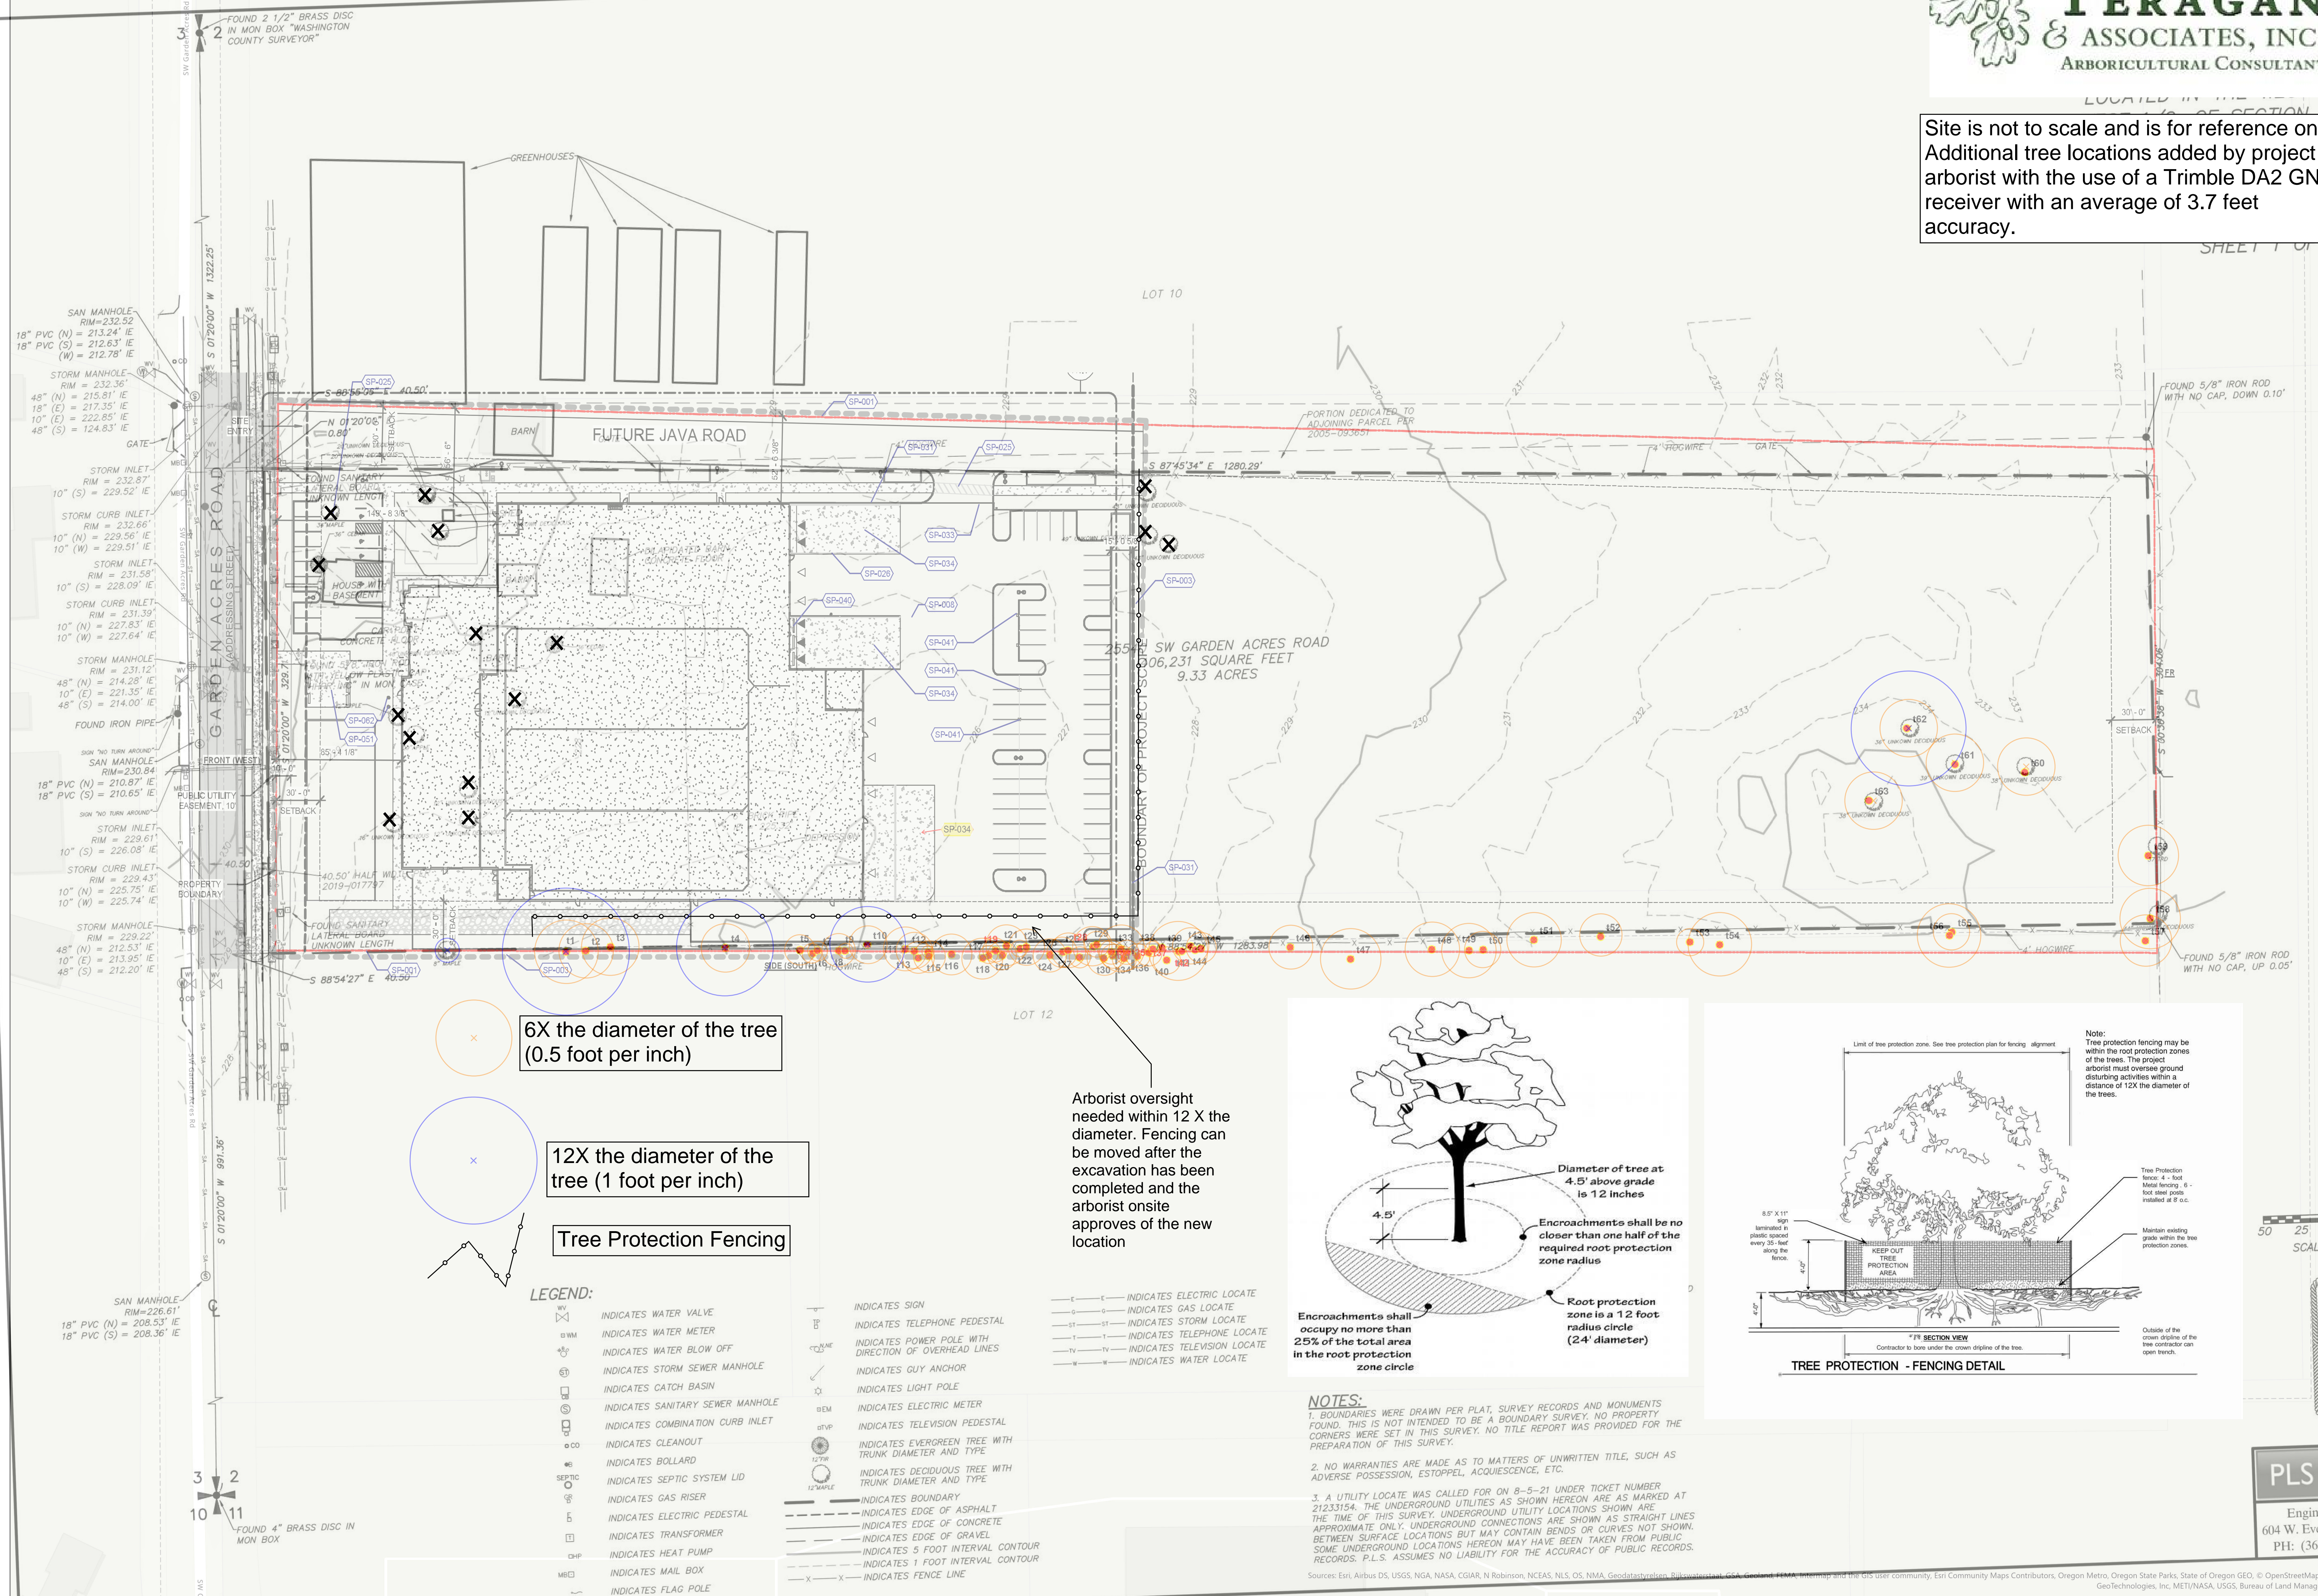
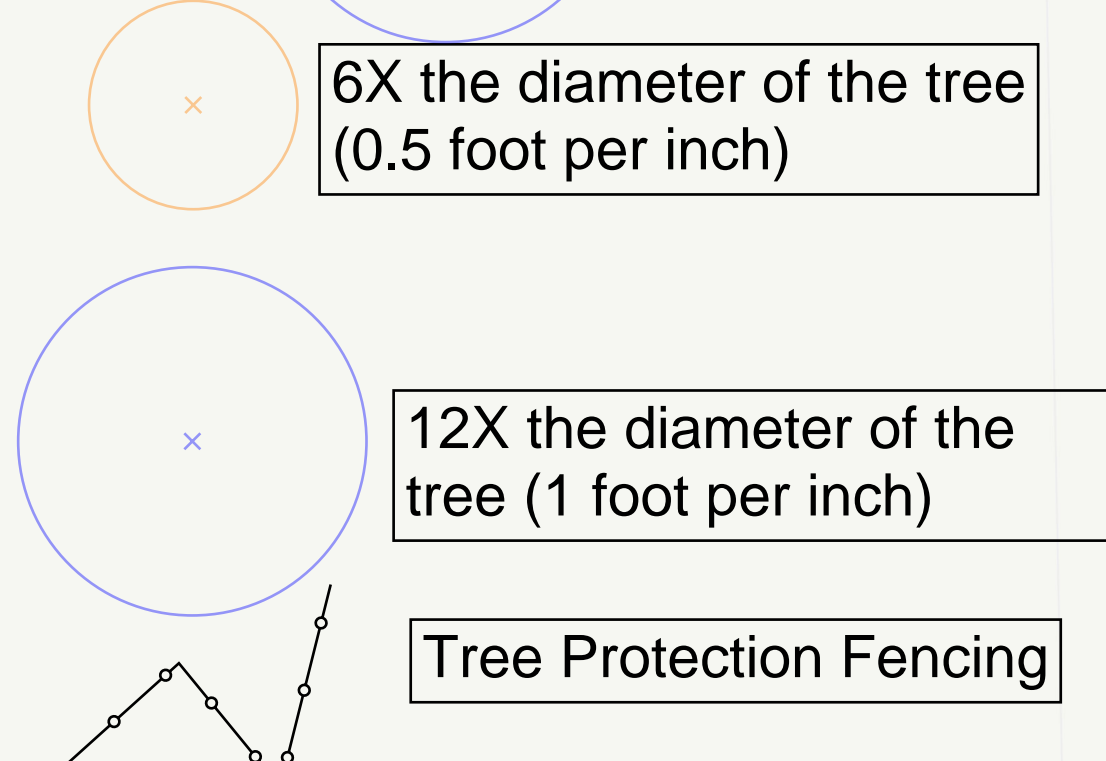
Arborist oversight needed within 12 X the diameter. Fencing can be moved after the excavation has been completed and the arborist onsite approves of the new location
