TREE PROTECTION PLAN

PRECISION COUNTERTOPS

25540 SW GARDEN ACRES ROAD,
SHERWOOD, OR 97140

Date Tuesday, April 4, 2023

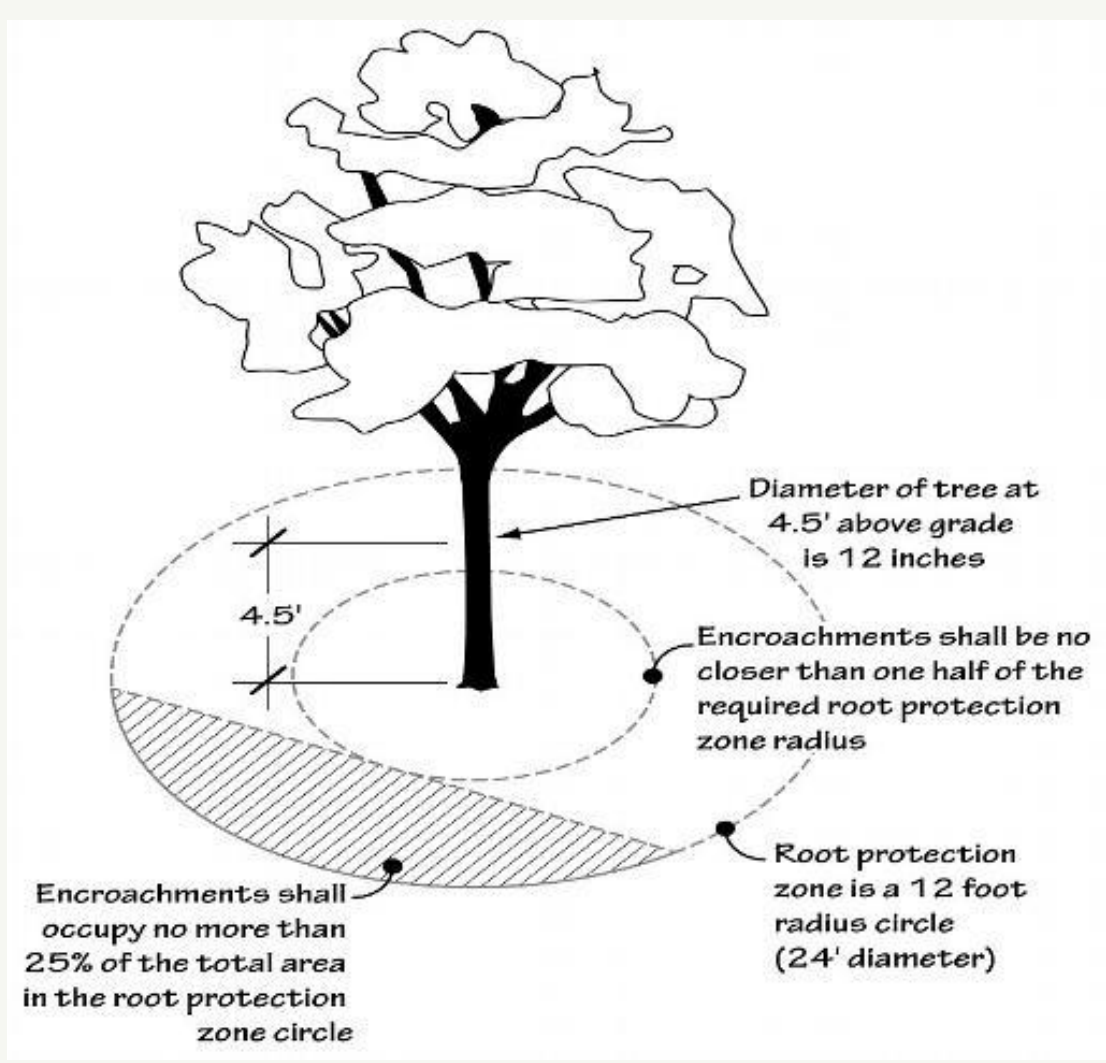
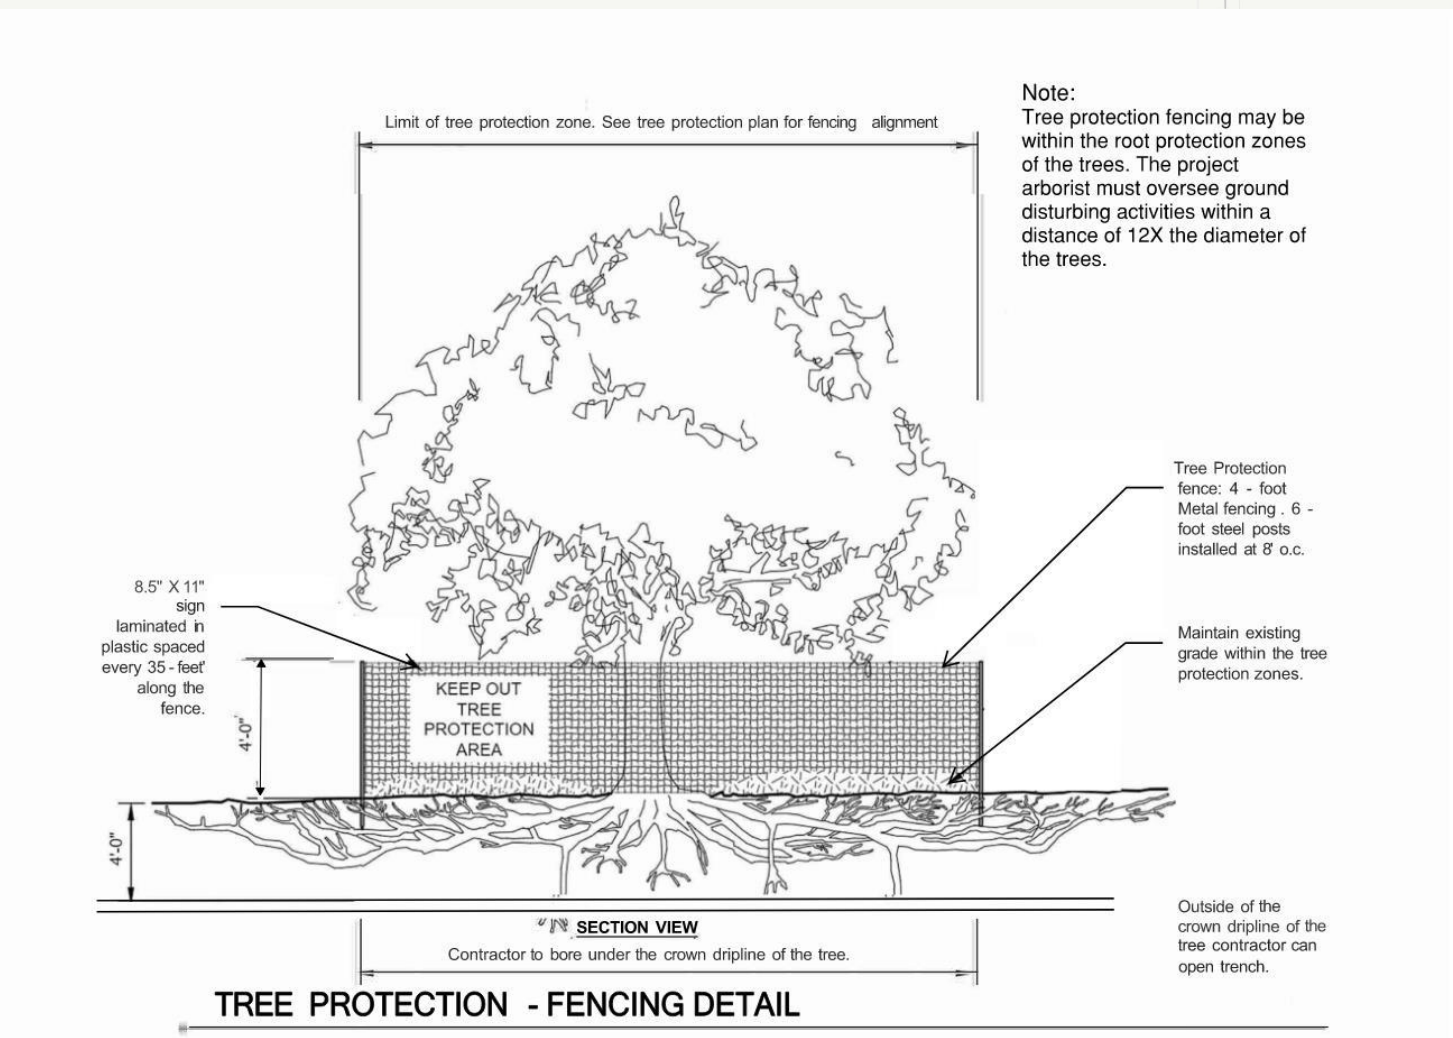
Arborist oversight needed within 12 X the diameter. Fencing can be moved after the excavation has been completed and the arborist onsite approves of the new location
